NATIONAL ADVISORY COMMITTEE FOR AERONAUTICS

TECHNICAL NOTE

No. 959

AXIAL FATIGUE TESTS OF 10 AIRPLANE WING-BEAM SPECIMENS
BY THE RESONANCE METHOD

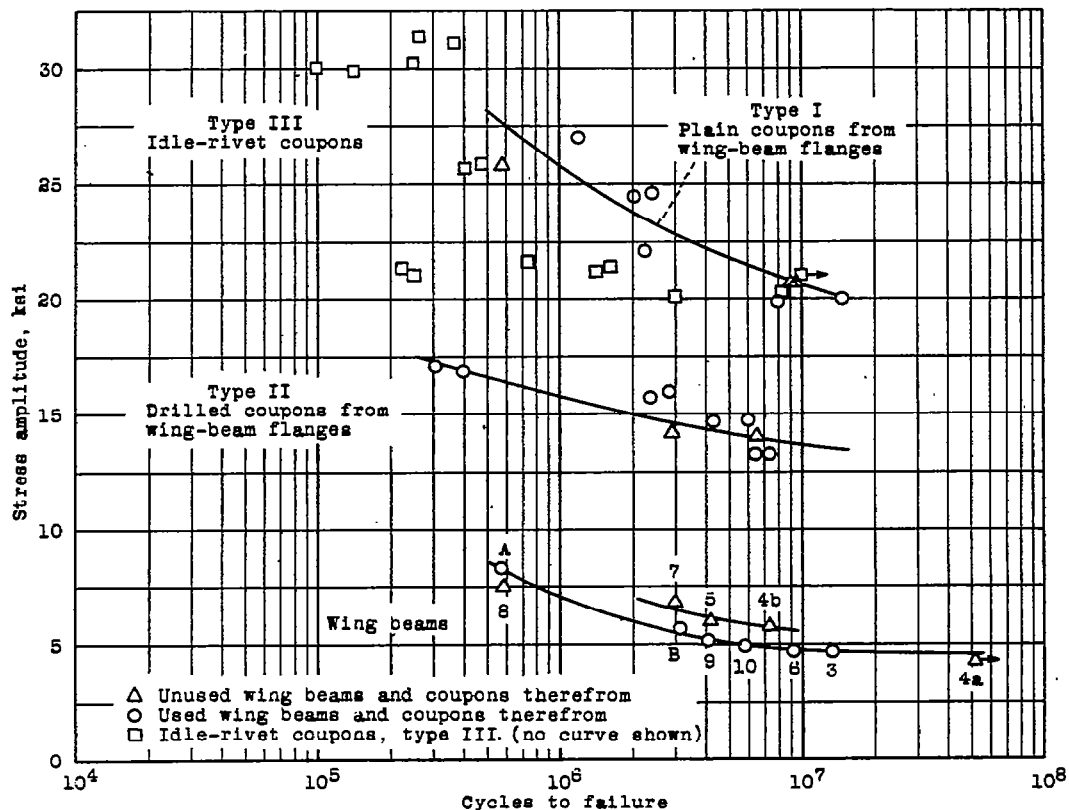
A smooth curve may be drawn through the plotted points in figure 9 with the exception of point 8; there is less scatter than usually is expected in fatigue results. The

The curve in figure 9 for the wing-beam specimens was drawn through the point A, although the fact that the web was not spliced placed this specimen in a different category from the others. It may be that point A should lie above a curve representing the fatigue strength of spliced specimens.

Figure 9.- S-N curves for wing beams and coupons.

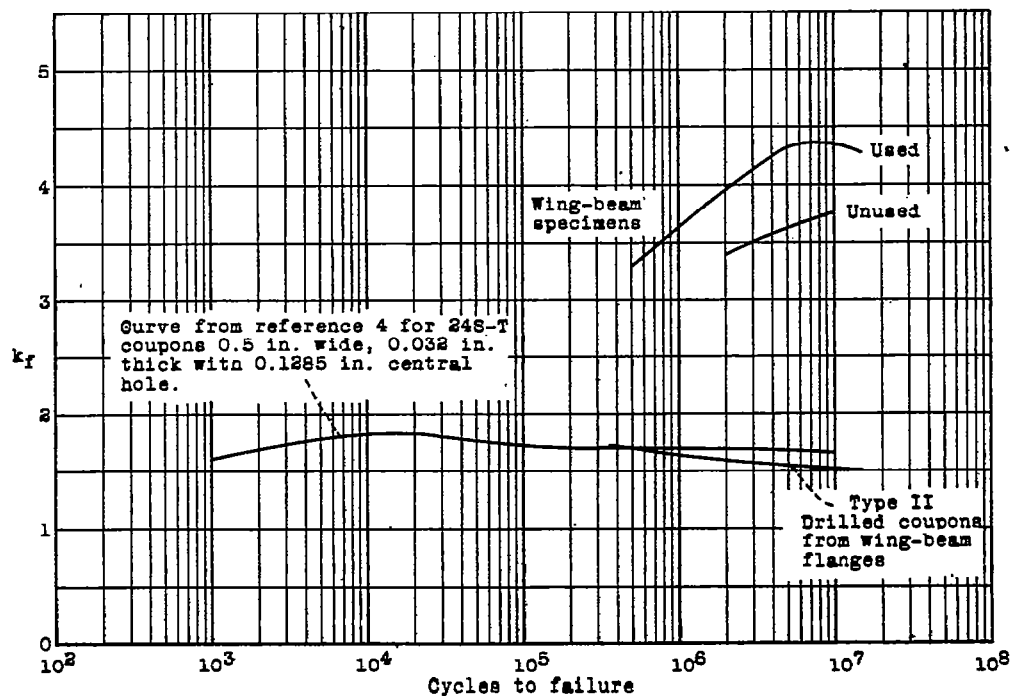
The results for both the plain and the drilled coupons are about the same as those previously obtained on 0.032-inch 24S-T sheet, which are reported in reference 4; k_f for these specimens is plotted in figure 10 for comparison.

Figure 10 shows that the fatigue stress concentration factor k_f for the wing beams is much higher than that for either the drilled or the riveted coupons; this indicates the presence of other, more damaging stress concentrations than that due to small rivet holes and idle rivets.

Figure 10.- Fatigue stress-concentration factors for wing-beam specimens and coupons.
